# Manhole Inspection Summary

Manhole # S17E1\_018MH

**Location** Address: **2905 whittington av**

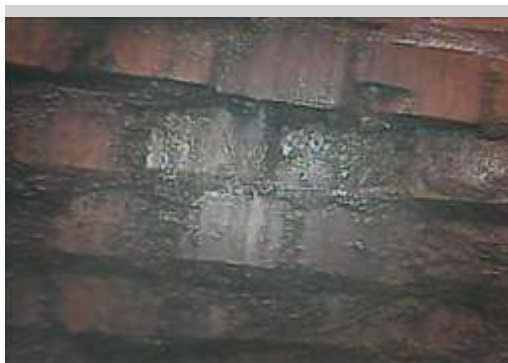
Defect 3

Infiltration: ☐ None ☐ Joint ☐ Cracks ☐ Mortar ☐ Roots ☒ **Wall**

infiltration @ barrel wall

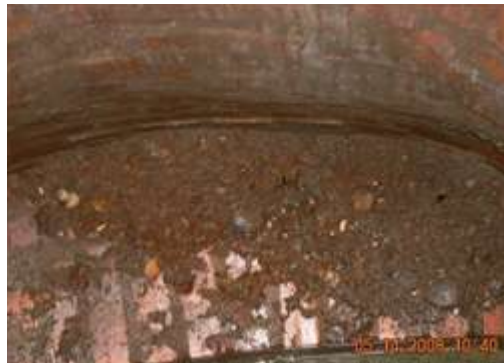
Defect 2

Condition: ☐ Sound ☐ Cracked ☐ Root Intrusion ☐ Deteriorated ☐ Leaks ☒ **Debris**

debris on bench

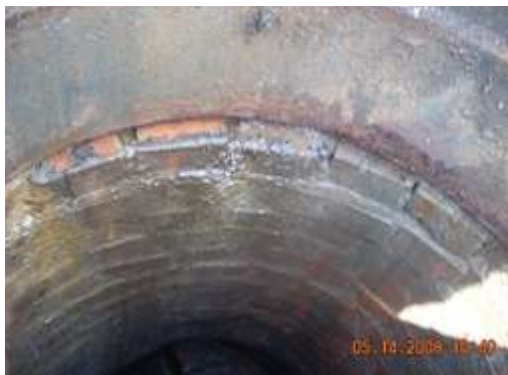
Defect 1

Infiltration: ☐ None ☒ **Joint** ☐ Cracks ☐ Mortar ☐ Roots ☐ Wall

infiltration @ corbel/frame joint

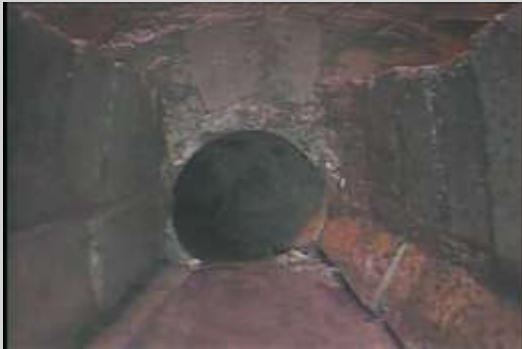
12 O'Clock Outflow

Comments **12 oclock pipe is higher than inflow pipe causing water to stand still in channel.**

6 in. Circular Gravity Sewer  
Pipe Out @ 12 O'Clock

Pipe Height: **6** (in.) Rod and Bar (Angled)  
Pipe Material: **Clay** ☐ Pipe Lined  
Invert Depth: **6.96** (ft.) Flow Characteristics: **None**  
Deposits: ☒ None ☐ Mud ☐ Sludge ☐ Debris ☐ Grease  
Silt Depth: **0** (in.) Deposits Extent:  
Infiltration: **None** Pipe Seal Cond: **Sound**

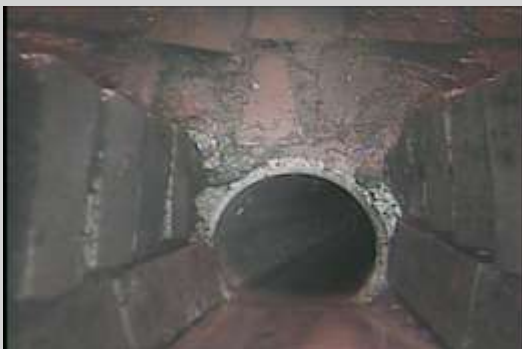
7 O'Clock Inflow

6 in. Circular Gravity Sewer  
Pipe In @ 7 O'Clock

Pipe Height: **6** (in.) Rod and Bar (Angled)  
Pipe Material: **Clay** ☐ Pipe Lined  
Invert Depth: **7.00** (ft.) Flow Characteristics: **Slow**  
Deposits: ☒ None ☐ Mud ☐ Sludge ☐ Debris ☐ Grease  
Silt Depth: **0** (in.) Deposits Extent:  
Infiltration: **None** Pipe Seal Cond: **Sound**
